Monitoring of Marseilles Dam Submersible Gates, Illinois River, Illinois

November 2001

Final report

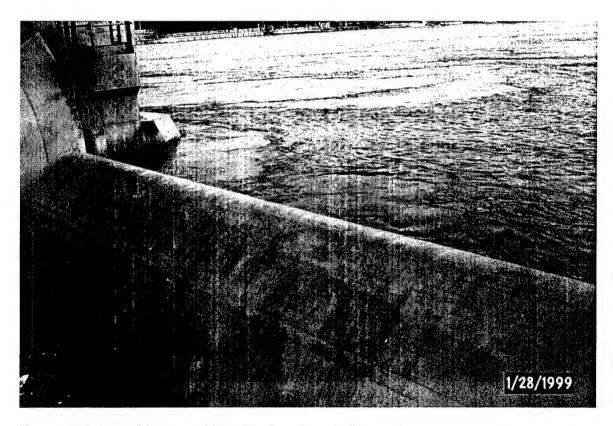
The new submergible gates are fully enclosed front and back and therefore less prone to ice buildup than the old gates. Also the gate arms are angled away from the pier walls with the clearance distance increasing moving away from the trunnions and towards the gate face. Running in submerged mode, spray icing and seal leakage do not result in ice buildup. During periods of extreme cold, the gates are moved or cycled every 2 hr to prevent freezing. Figure 11 shows one of the new gates at Marseilles Dam.

Figure 11. Submersible gate at Marseilles Dam in underflow mode

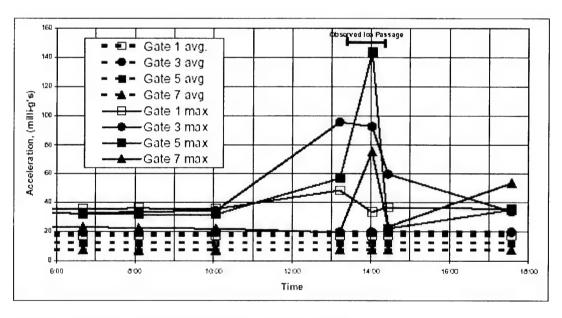
Figure 32. Maximum gate accelerations, 28 January 2000

By the next morning, 26 January, thin black ice had reformed on the pool. This cover remained in place until about 13:00 on 28 January when strong easterly winds flooded the ice cover's upstream edge and moved the sheet towards the dam. Within half an hour, most of the ice on the pool had moved past the central gates on the dam, which were submerged 0.2 m (0.5 ft) at the time. The greatest accelerations, in the 95 to 145 milli-g range, occurred at centrally located Gates 5 and 3 (Figure 32).

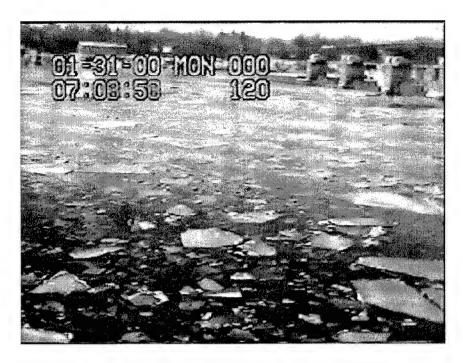
Figure 33. Fragmented ice in pool, morning of 31 January 2001

During 29 and 30 January, the pool was open, with intermittent disperse floes passing. At dawn on the morning of 31 January, fractured floes filled the image area (Figure 33) At this time the gate openings were even at 0.4 m (1.5 ft). At 07:17, strong westerly winds caused the ice on the left side of the pool to shift upstream. At 07:27 the ice floes on the left side of the pool moved downstream and began to pass Gates 1 and 2. Between 07:30 and 07:50, the ice on the right hand side of the pool began moving, and at 07:50, the central ice moved. After 08:04, the pool was, for the most part, ice-free.

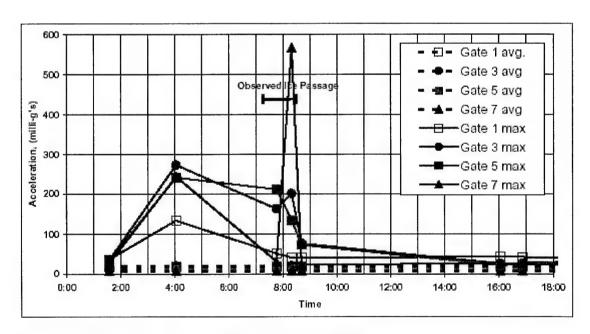
08:00, the maximum acceleration for Gate 7 was 570 milli-g's. Because Gate 7 lies outside of the image area, it is unclear what caused this high value.

Figure 34. Maximum gate accelerations, 31 January 2000

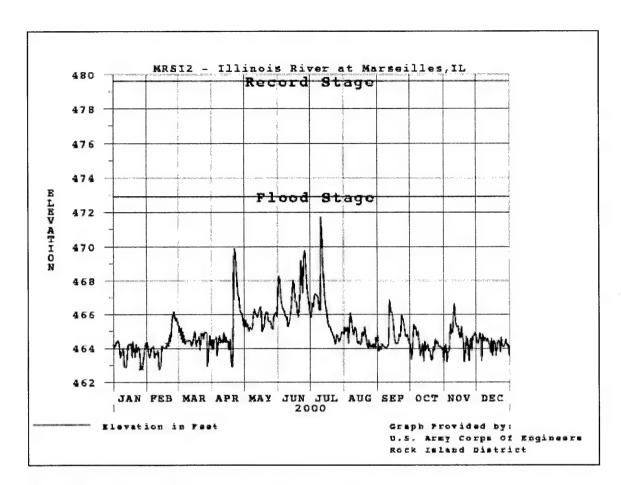
Figure 40. Time-history Illinois River stages at Marseilles

For periods when a significant rise in river stage occurs, as indicated in Figure 40 between the periods April – July 2000, multiple gate operations are required to pass the inflows. These gate operations are characterized by larger raised gate openings 1.5 - 2.1 m (5.0 - 7.0 ft) for longer periods of time (days) to maintain the upper pool water levels.

A significant rise in river stage occurred, as indicated in Figure 40, between the periods April – July 2000, and required multiple gate operations to pass the inflows. These gate operations are characterized by larger raised gate openings 1.5 - 2.1 m (5.0 - 7.0 ft) for longer periods of time (days) to maintain the upper pool water levels.

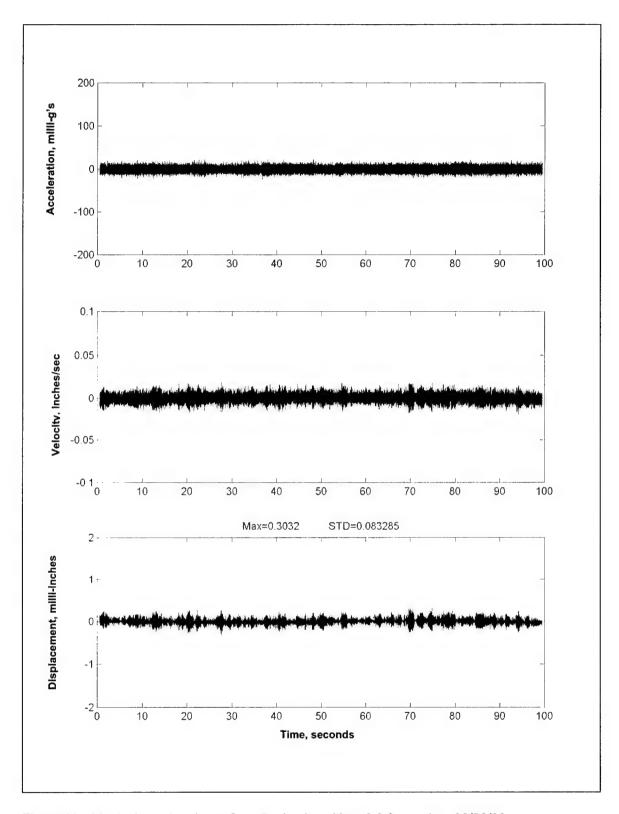
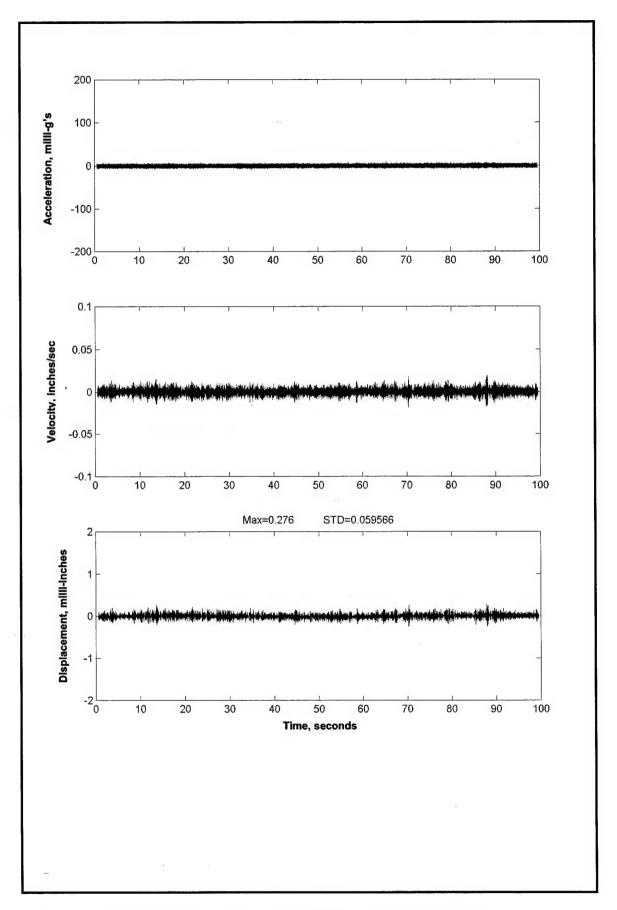
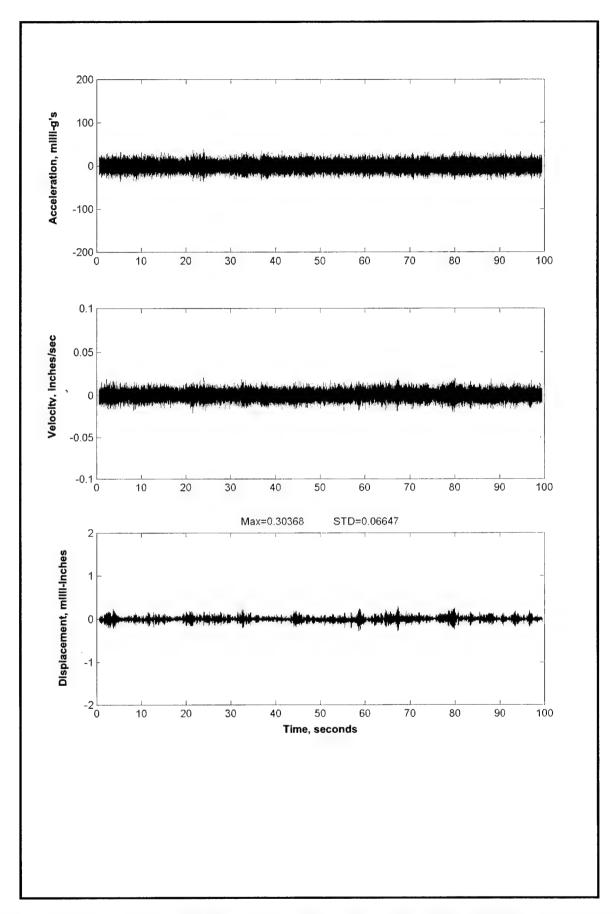
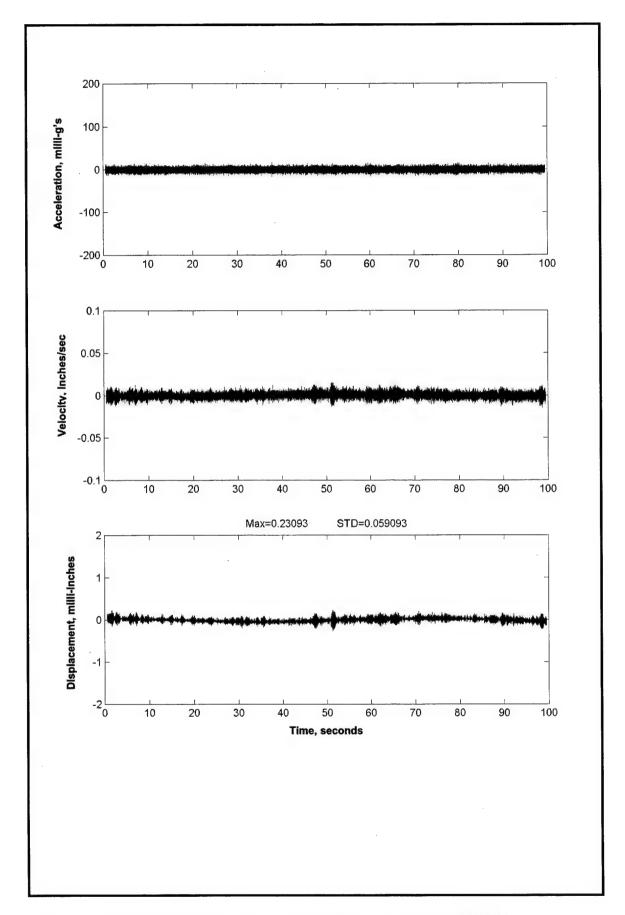
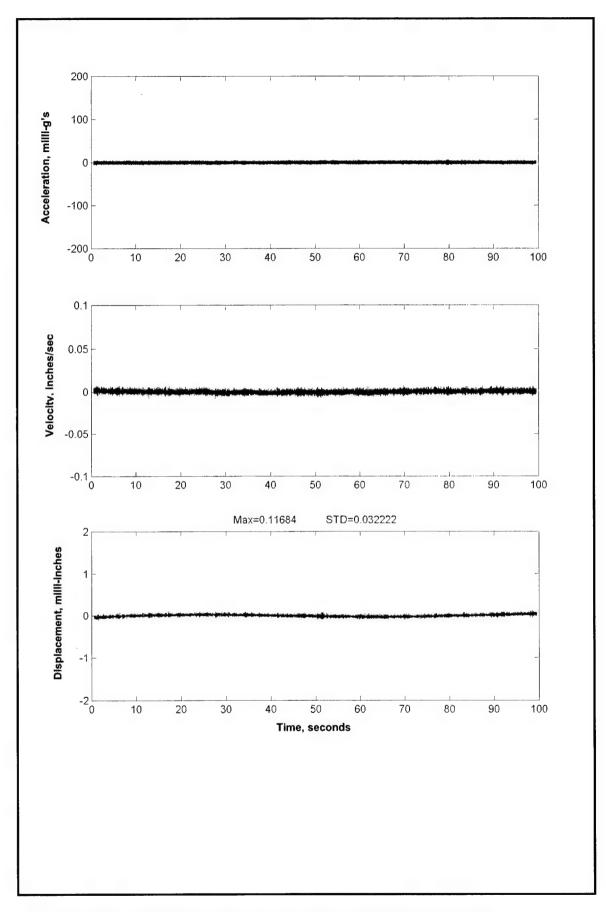
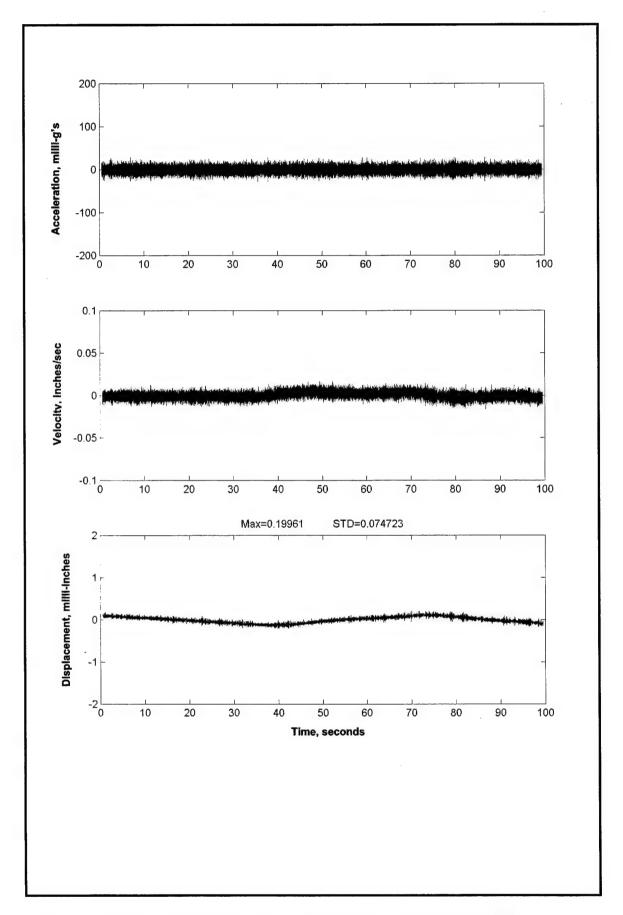
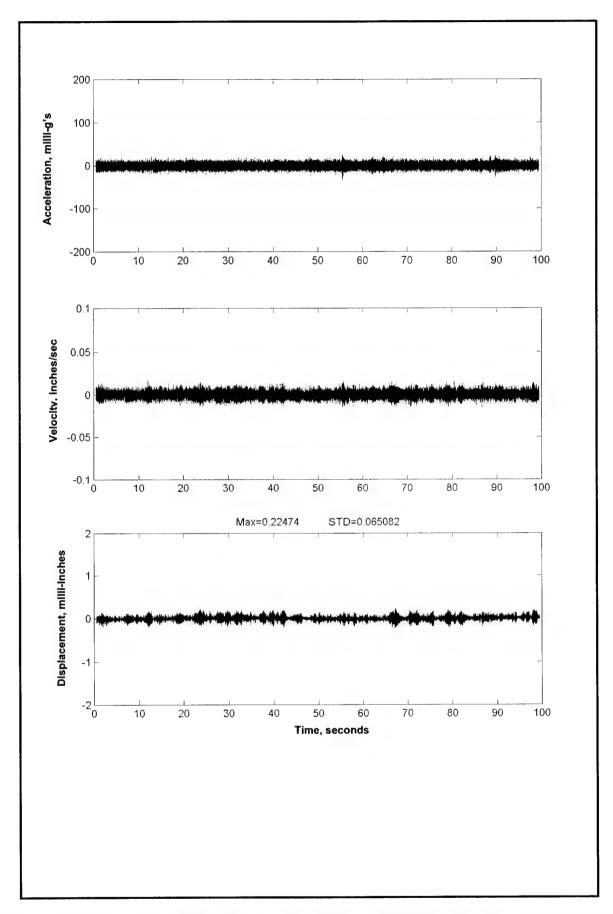
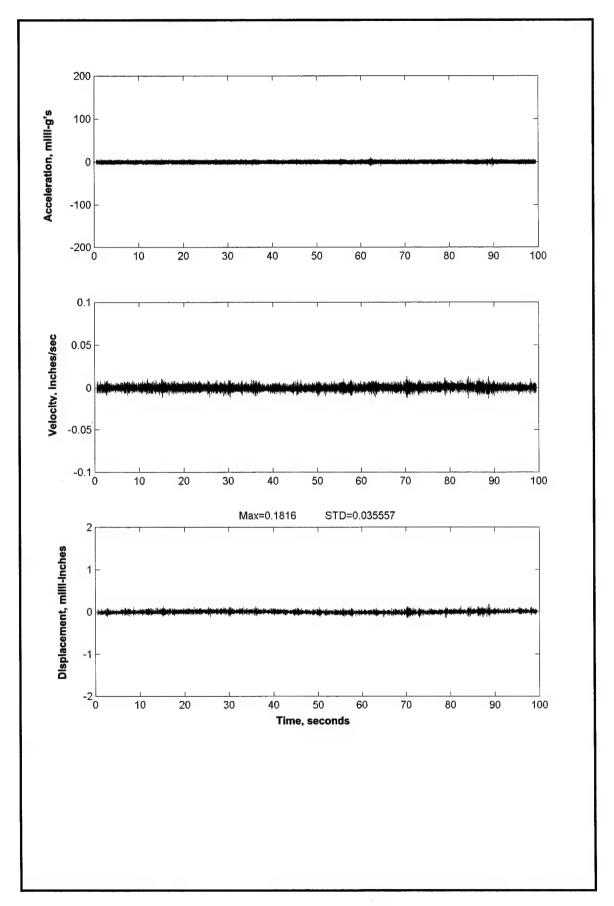
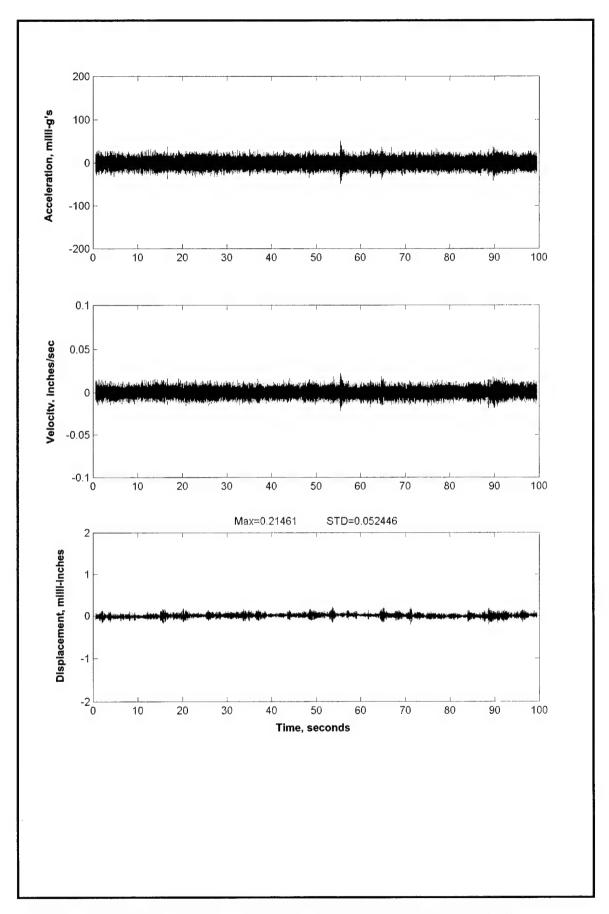
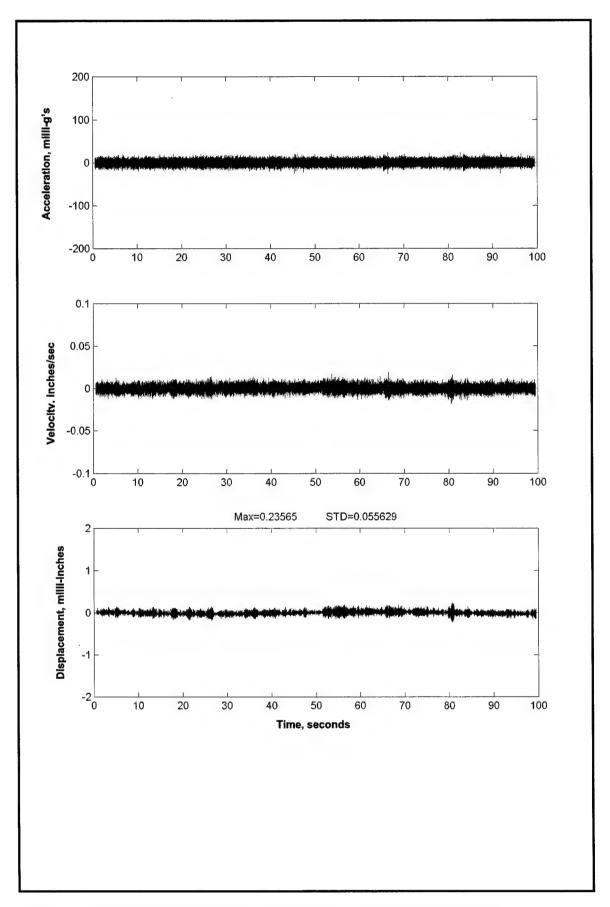
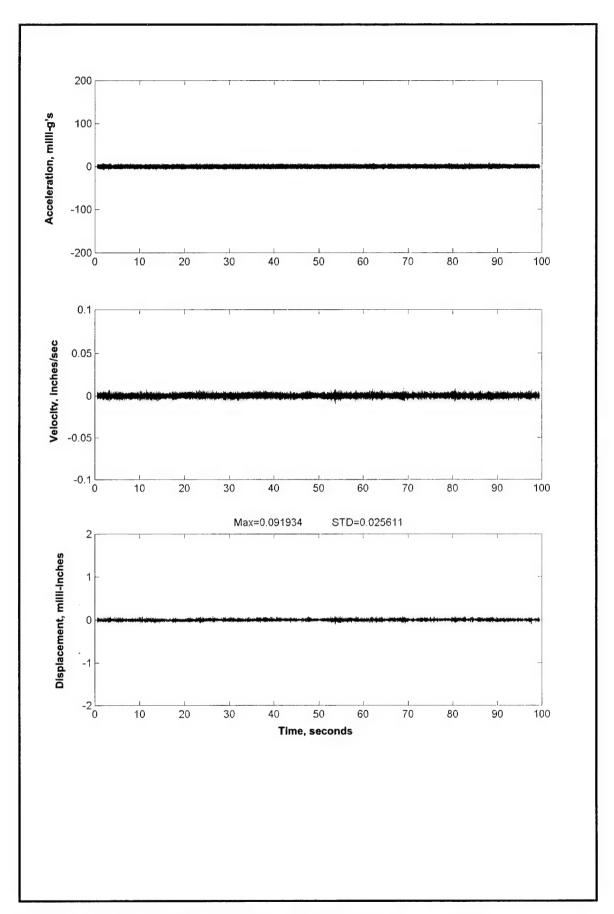
The summaries of vibration levels recorded for the various instrumented gates operated at the larger openings during this period are presented in Tables 15–19. Tables 15-16 and Figures 41 - 52 are representative sampling of vibration levels occurring with two-gate operation for gate openings ranging from 0.6 - 1.5 m (2.0 – 5.0 ft). Tables 17- 19 and Figures 53 - 79 are a representative sampling of the vibration levels occurring with a three-gate operation and gate openings ranging from 0.3 - 2.1 m (1.0 – 7.0 ft). The maximum values of vibration level and displacement observed during these operations were 0.20 g's and 0.005 cm (0.002 in.), respectively. These values represent the predominant vibration levels and displacements to which the gates are subjected for the particular gate openings during a particular segment of time and indicate that very insignificant movement is occurring for these raised gate operation conditions.

The vibration levels indicated that for these raised gate operation conditions very insignificant gate movement is present. The maximum vibration level values and displacement observed during these operations were 0.20 g's and 0.005 cm (0.002 in.), respectively.

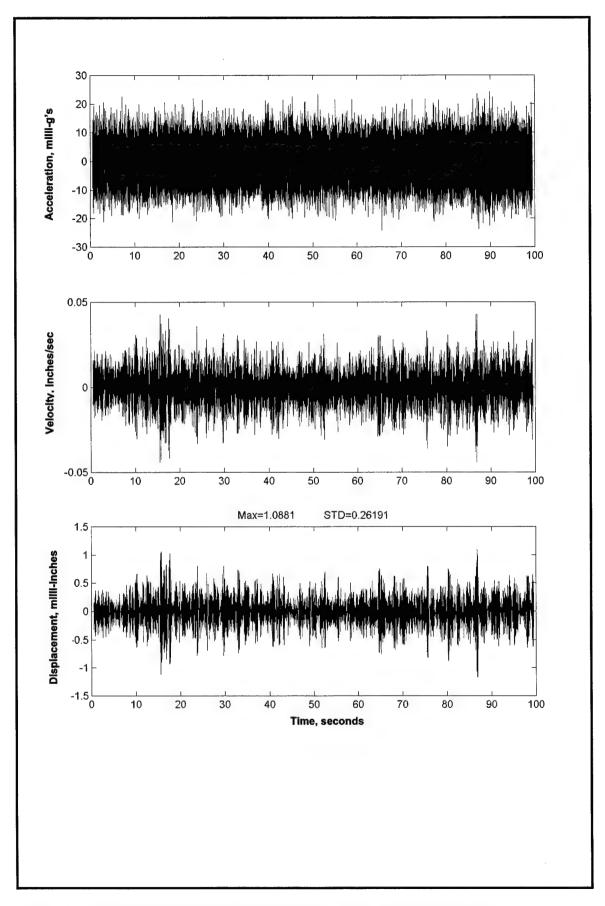
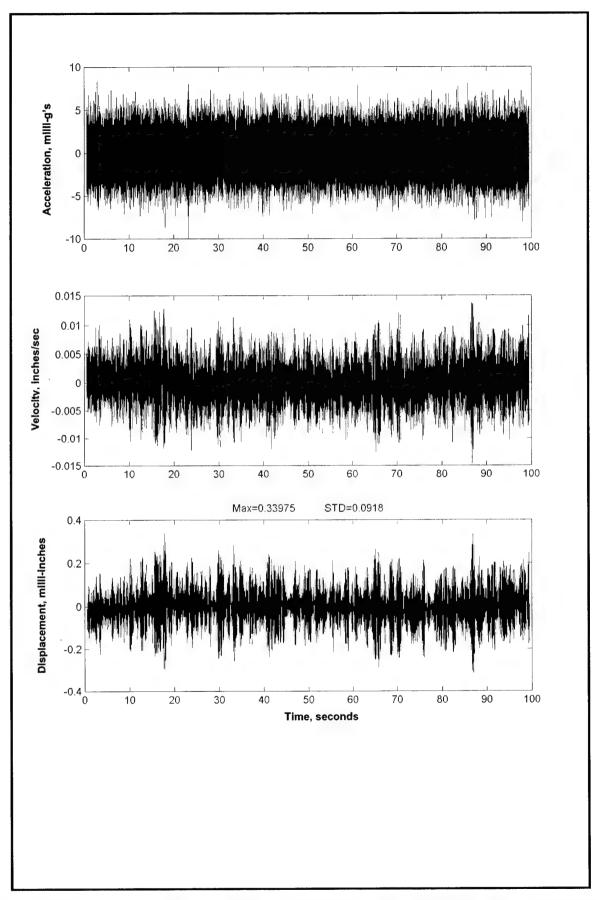
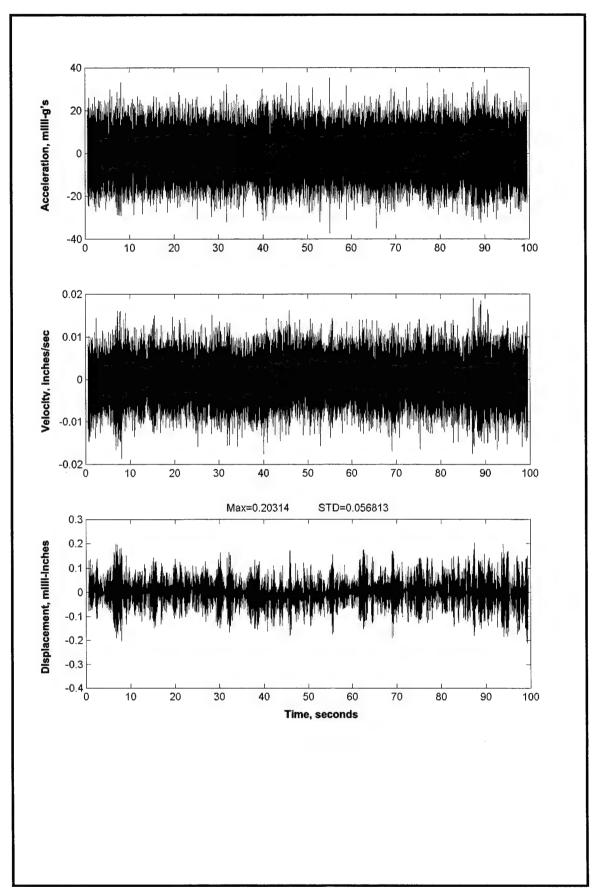
In general the vibration levels and displacements were extremely small (less than $0.3~\rm g$'s and less than $0.002~\rm cm$ $(0.001~\rm in.)$, respectively). Tables 21-23 and Figures 80 - 82 are a representative sampling of the vibration levels occurring with a four-gate submerged operation and gate openings ranging from 0.4 - $0.6~\rm m$ $(1.5-2.0~\rm ft)$. The maximum values of vibration level and displacement observed during these operations were $0.06~\rm g$'s and $0.005~\rm cm$ $(0.002~\rm in.)$, respectively. These values represent the predominant vibration levels and displacements to which the gates are subjected for the particular gate openings during a particular segment of time and indicate that very insignificant movement is present for these submerged gate operation conditions.

Figure 80. Vertical accelerations and displacements, Gate 5, submerged position, -2.0-ft submerged position, 02/14/00

Figure 81. Radial accelerations and displacements, Gate 5, -2.0-ft submerged position, 02/14/00

Figure 82. Transverse accelerations and displacements, Gate 5, -2.0-ft submerged position, 02/14/00
